Delaware County Infiltration & Inflow Reduction

CSEAO ANNUAL SUMMER CONFERENCE

JUNE 17, 2025

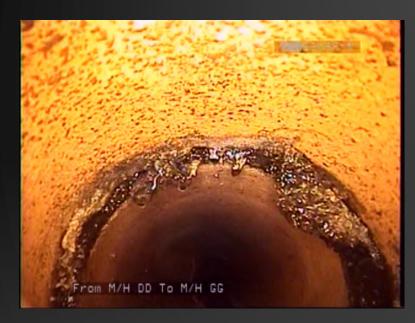
Leaking Joint

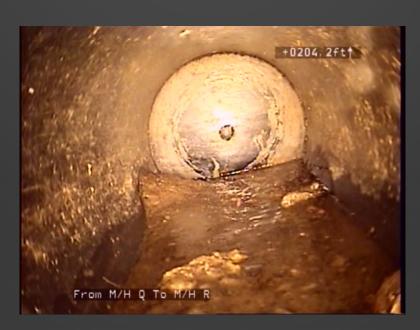
Leaking Stub

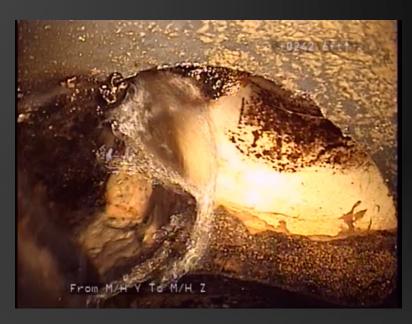
Leaking Wye

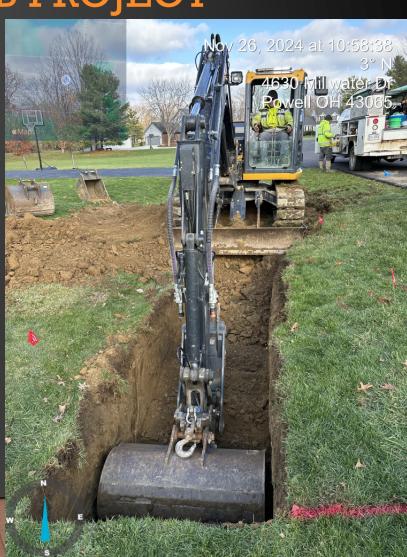
- 42 full-wrap lateral liners with 5' extension
- 3 taps not restored
- 5 open-cut tap repairs
- Only defective taps were lined/repaired (47 of 69)
 - Break-in/hole
 - Infiltration
 - Encrusted deposits
 - Joint offset/ separated
 - Protruding

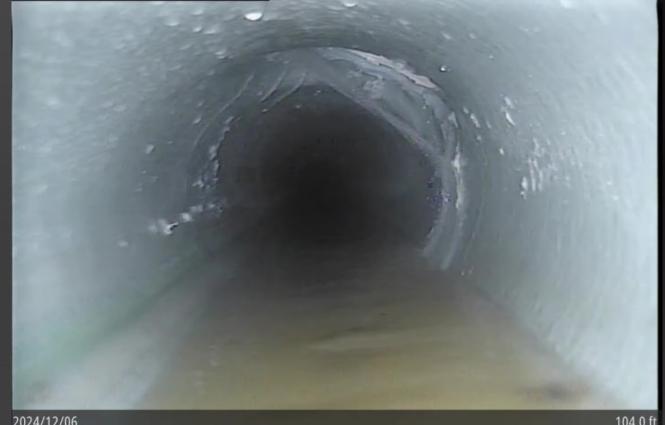
- LESSONS LEARNED:
- Require notice before cleaning & inspection
- I&I migrated between liner and host pipe to two taps that were not lined
 - Consider lining ALL taps

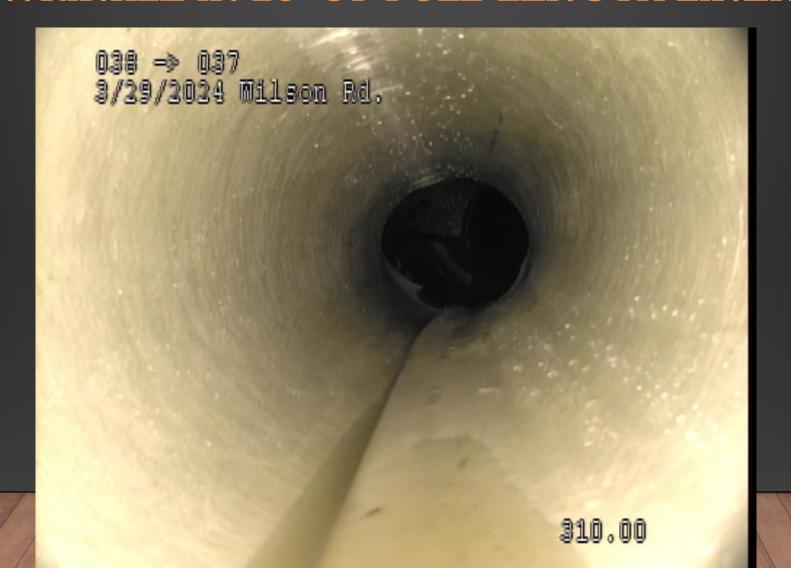
WRINKLE IN 25' OF FULL-LENGTH LINER

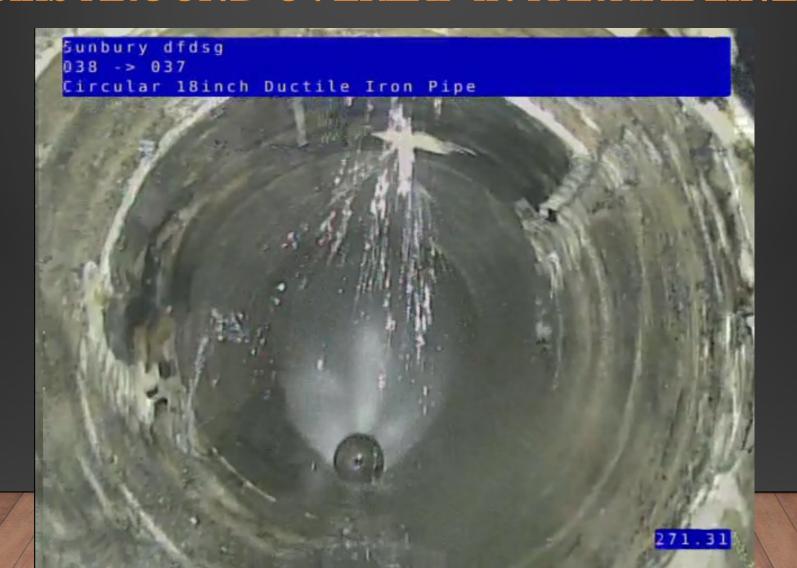
LEAKS AROUND OVERLAP IN PARTIAL LINERS

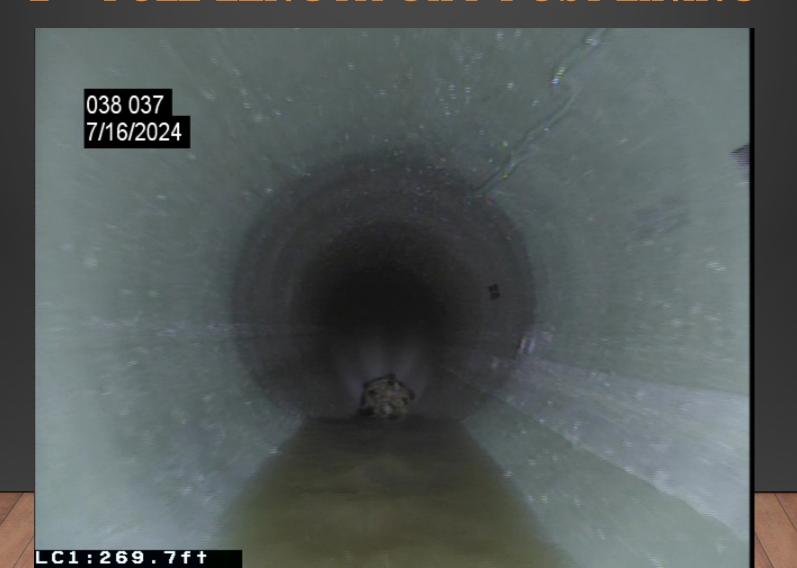
2ND FULL-LENGTH CIPP POST-LINING
