Delaware County Infiltration & Inflow Reduction

CSEAO ANNUAL SUMMER CONFERENCE

JUNE 17, 2025

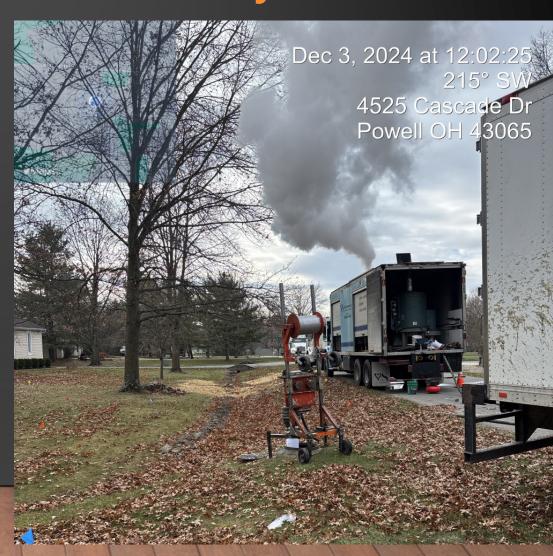
- LESSONS LEARNED:
- Require notice before cleaning & inspection
- I&I migrated between liner and host pipe to two taps that were not lined
 - Consider lining ALL taps

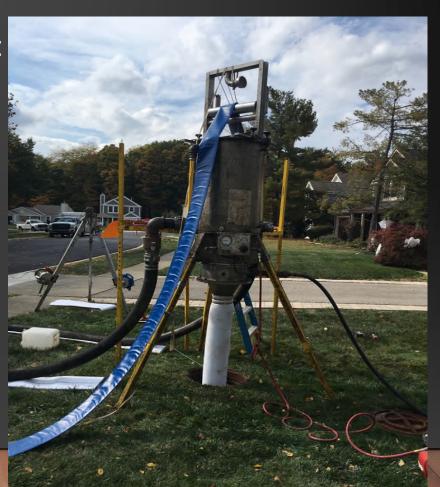
- Delaware County's 1st sewer lining project
- 2,890 LF cured-in-place pipe (CIPP)
- Geopolymer lining of manholes
 - 2 in Highmeadows
 - 7 in Alum Creek service area
